Terminal Tractor Service Bulletin

Subject: Ottawa T2 Motor Mounts			
Product: Medium Terminal Tractor	Bulletin # SB16TI0060	Date: 8-August-2016	Pages: Page 1 of 2
To: All Kalmar Sales Companies		From: Medium Terminal Tractor Product Support

Units Affected: Ottawa T2 model terminal tractors

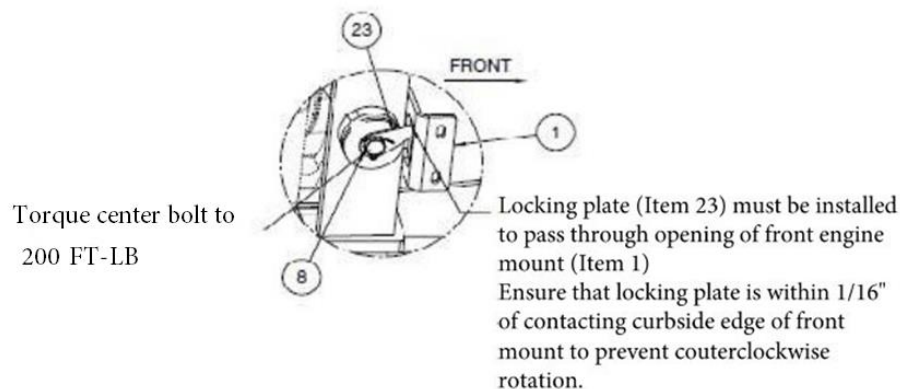
1. The locking tab for the front motor mount may not be properly engaged with the slot in the motor mount. If not properly engaged the front motor mount attaching hardware can loosen.
2. The hardware attaching the rear motor mount to the flywheel housing can loosen during operation. If the truck is operated with these bolts loose it can result in damage to the flywheel housing and / or the motor mount.

Solution: The front and rear mounts should always be inspected as part of normal preventative maintenance. Incorrectly installed front mount locking tabs should be reused and installed correctly. Loose rear mount attaching hardware at the flywheel housing should be removed and reinstalled using blue Loctite and torqued to 40 ft-lbs.
